## Positive Effect for Using Novel Monitoring System on Reciprocating Compressor

Mohammed M. Ayoub<sup>1,\*</sup>, Wagih W. Marzouk<sup>2</sup>, Ibrahim M. M. El Moghazy<sup>1</sup>

Enhancing asset reliability and optimizing preventive maintenance for reciprocating compressors, which are vital rotating equipment in various industries, particularly within oil, gas, and refinery plants, stands as a pivotal challenge for asset management today. A review of existing literature has shown that numerous development efforts have been made to establish monitoring techniques for reciprocating compressors. Nevertheless, previous research has not delved into the continuous monitoring of the mechanical behaviors and clearances of compressor crankshafts, crossheads, and cylinders. Here, we employ additional proximity probes within an online monitoring system to measure all compressor clearances, aiming to optimize preventive maintenance for reciprocating compressors. K-1101B reciprocating compressor from Egyptian refining company and solid works have been used based on actual compressor mechanical clearances obtained during at 4000, 8000 and 12000 running hour's compressor overhauls to trend t

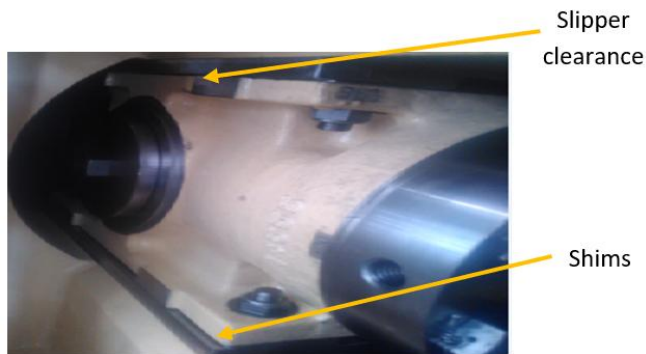
**Figure 6: The slipper clearance and adjusted shims**

The slipper clearance, which refers to the gap between the crosshead and the crosshead shoe, was meticulously measured. It was observed that the slipper clearance for the compressor during the three overhauls was slightly outside the specified tolerance range of 0.20 mm to 0.30 mm, as indicated in Trend 2. This deviation can be attributed to the deteriorating condition of the shims used to adjust the clearance between the crosshead and the crosshead shoe, as depicted in Figure 6.

Furthermore, it's noteworthy that the slipper clearance varied between the two sides of the crosshead and the crosshead shoe. Such discrepancies can result in elevated stresses on the connecting rod bearings and piston rod packings during compressor operation. This situation necessitates attention and potential corrective actions to maintain the proper functioning and longevity of these critical components.

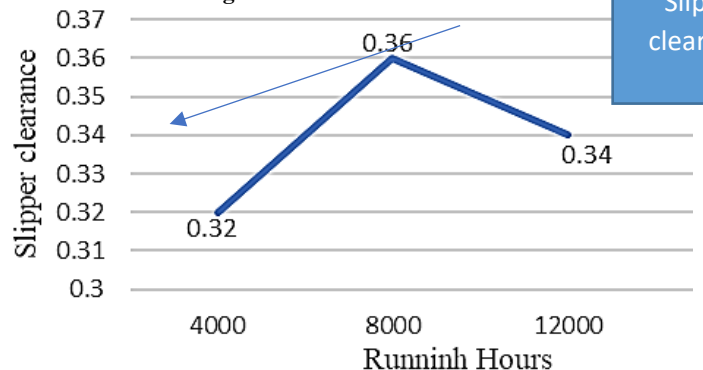
**Trend 2: The slipper clearance at 4000, 8000 and 12000 running hours**

Regarding the pressure packing, its failure was linked to the piston rod's vertical run-out not being properly adjusted, as indicated in trend (3), as well as issues with the crosshead clearance, as shown in trend (2). However, it is worth noting that the incorrect piston rod vertical run-out was detected for a second time after recalibrating the rod drop system.

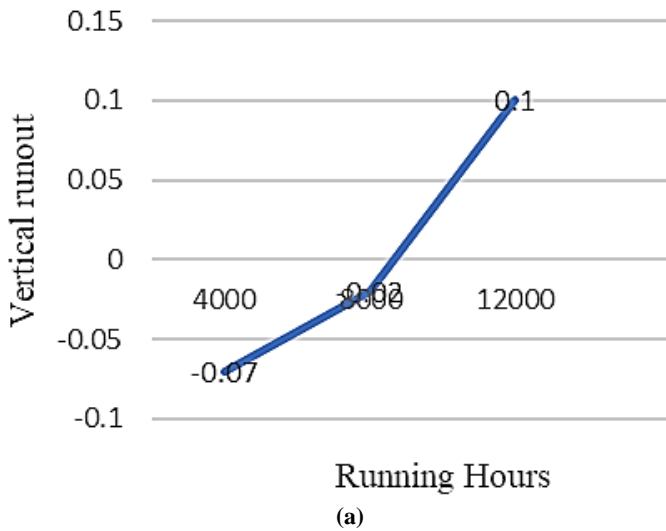
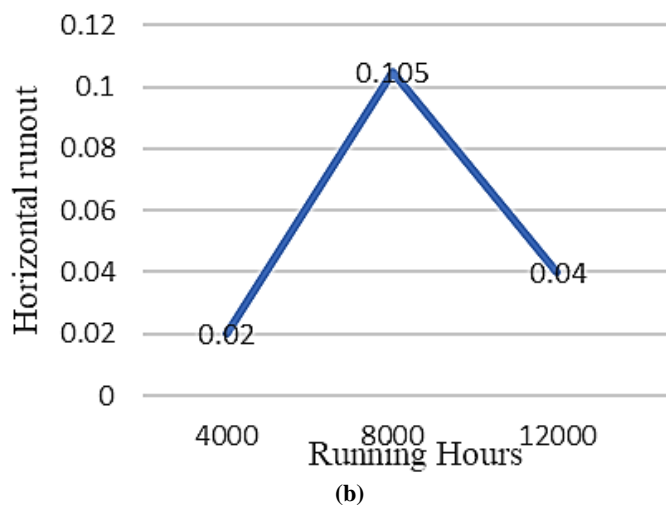
**Trend 3: The Vertical and horizontal run out measurement at 4000, 8000 and 12000 running hours**

Vertical run-out measurements for the piston rod were conducted using a dial indicator fixture, as shown in Fig. 7. The vertical measurements revealed a discrepancy between the actual measurements and the reference measurements (where the reference measurement range is defined as 0.106 to -0.094 according to the Manual), as illustrated in Trend 3. This disparity can be attributed to wear in the rider ring and potential issues with the piston bottom and cross head clearance.

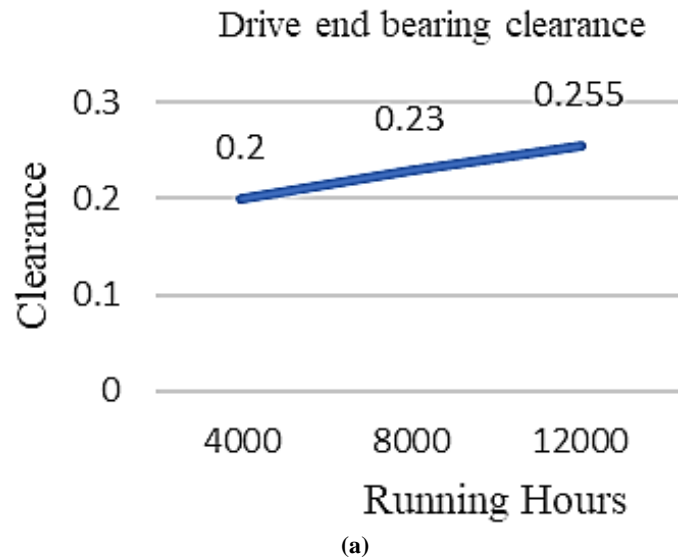
**Trend 4: The Drive End main bearing clearance at 4000, 8000 and 12000 running hours**

The clearance between the crankshaft and the non-drive end journal bearing was measured to be 0.2 mm at 4000 hours of operation and increased to 0.24 mm at 12000 hours, as depicted in Trend 4. This trend suggests that over time, there has been a gradual increase in the clearance between these components.

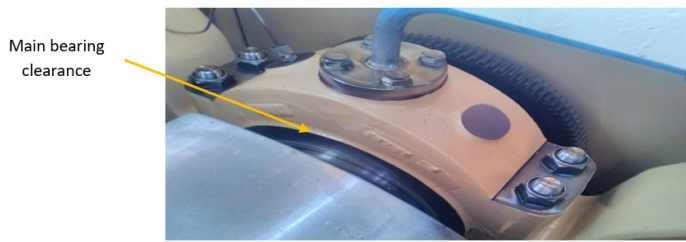
Figure 9: The bearing clearance location

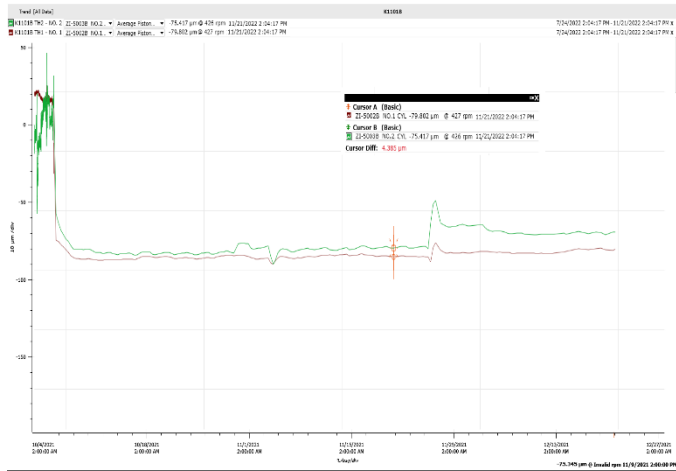
Figure 11: Rod drop reading for two cylinders

In particular, the ZI-5002B rod drop reading for cylinder number one, as shown in Fig. 11, indicated a value of 79 mils, equivalent to 2 mm. Meanwhile, for ZI-5003B, which corresponds to cylinder number two, the reading was 75 mils, equivalent to 1.9 mm. Upon comparing these rods drop readings with the actual piston bottom clearances, a discrepancy of approximately 0.4 mm was observed.

This variance can be attributed to the fixed position of the rod drop probes, which are situated at a distance from the actual piston bottom clearance and the condition of the piston rider ring. The

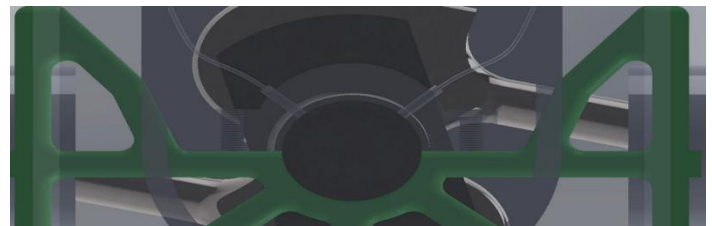
Figure 14: Main bearing proximity probes

1. Two proximity probes for crankshaft main bearings for measuring the clearance between the journal bearing and the crankshaft, as depicted in Figure 14.
2. Two proximity probes fix on the crosshead shoe both sides for measuring the slipper clearance between the crosshead and the crosshead shoe, on both sides of the crosshead.
3. Two proximity probes for measuring the piston bottom clearance at both top dead center and bottom dead center for each compressor cylinder.

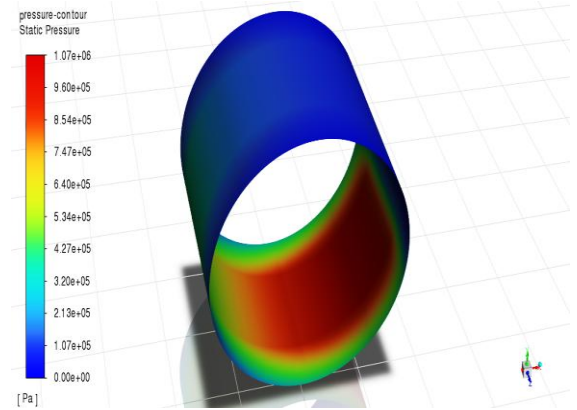
**Figure 17: DE counter at 0.255 mm clearance**

1. Drive End Bearing: In the case of the drive end bearing, the contour static pressure exhibited a direct proportional relationship with the bearing clearance. As the clearance increased, the static pressure also increased. For instance,

static pressure increased from  $9.05 \times 10^5$  Pascals at diametral clearance 0.21 mm to  $1.01 \times 10^6$  Pascals at diametral clearance 0.23 mm, as illustrated in Fig. 15, Fig. 16. This increase in static pressure was attributed to the growth in the minimum fluid film thickness [12], leading to an increase in the coefficient of friction. However, once the bearing clearance reached 0.26 mm, the static pressure became constant as illustrated in Fig. 17 due to the fixed minimum fluid film thickness and coefficient of friction.
